How To Repair a Cushcraft R5

How To Repair a Cushcraft R5
Overview - R5 Matching Unit Rebuild by G0WCW using EI7BA method

This article describes how to rebuild a matching unit of a Cushcraft R5 vertical.

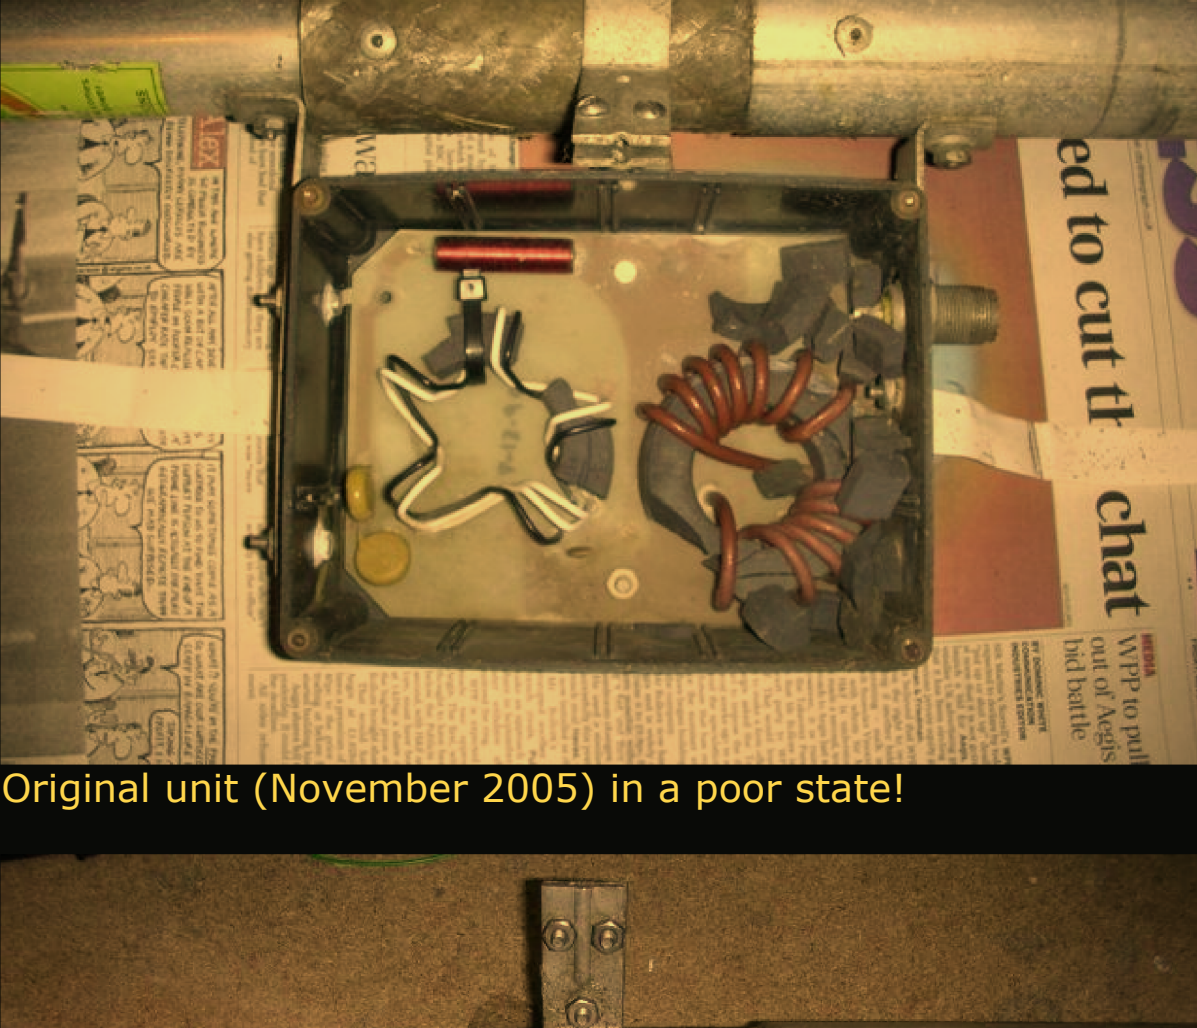
It started when I found an old R5 at the club shack (<http://www.mrs.bt.co.uk/mrs>) that was non-functional. The main aluminium parts looked fine, but the matching unit was faulty (see first picture below).

Original unit (November 2005) in a poor state!

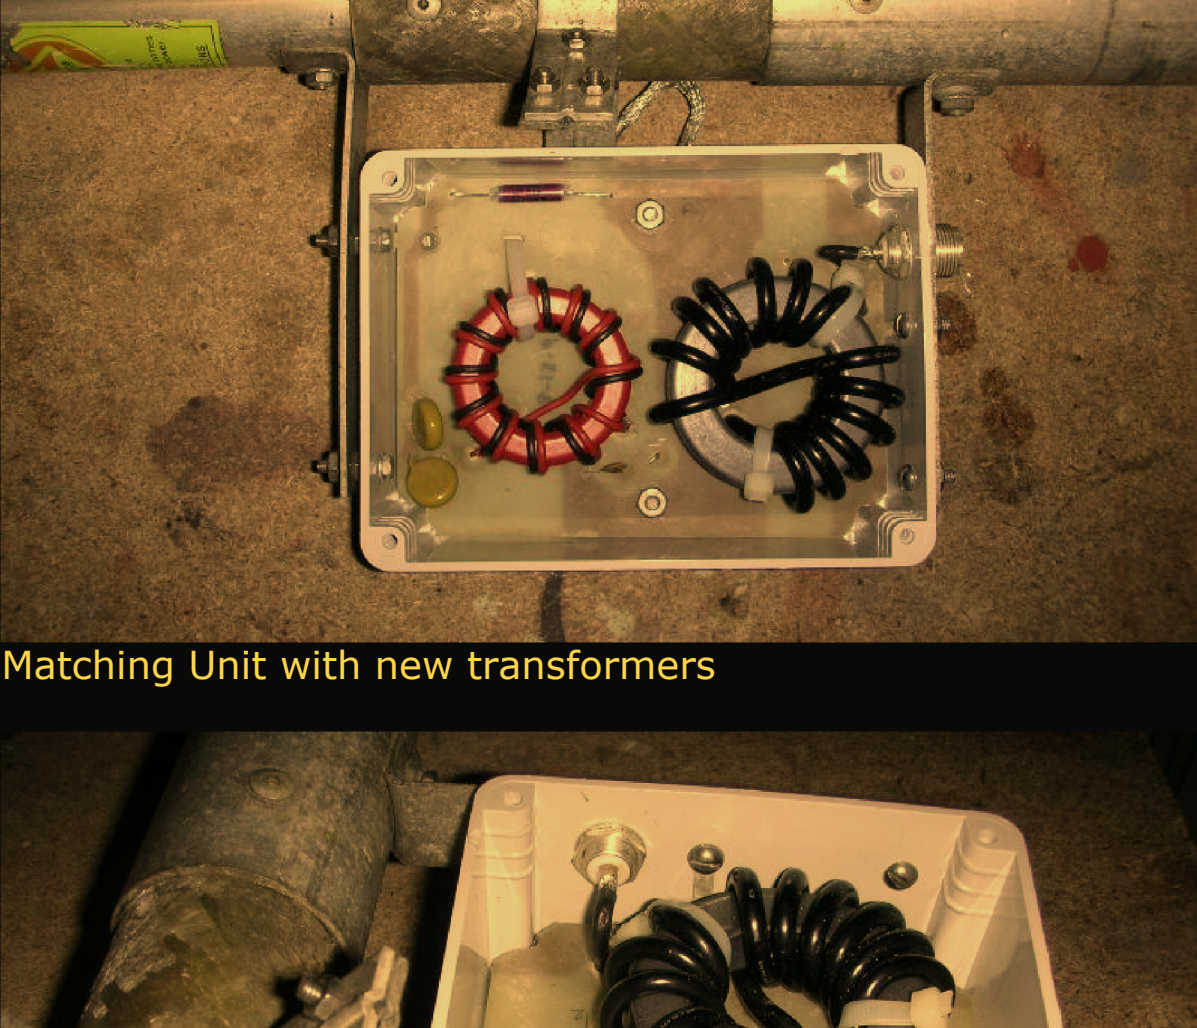
Matching Unit with new transformers

In essence, I used the method described by John and this worked fine. The two toroid cores came from<http://www.jabdog.com/> and at the time of writing, they are still in stock if you need them in the UK.

You need to order a "Q1 material Ferrite core (FT240-61)" for the choke and a "Amidon Iron Dust core T200-2" for the balun. This is to keep at as per the recipe from John, but you could use two "Q1 material Ferrite core (FT240-61)" for the balun with six bifiliar turns instead of 11. Cost is about four UK pounds pounds for the T200-2 and just over eight UK pounds for the FT240-61.

The wire for the balun is 1.0mm from a new one metre piece of twin-and-earth (old style red and black). This wire works fine.

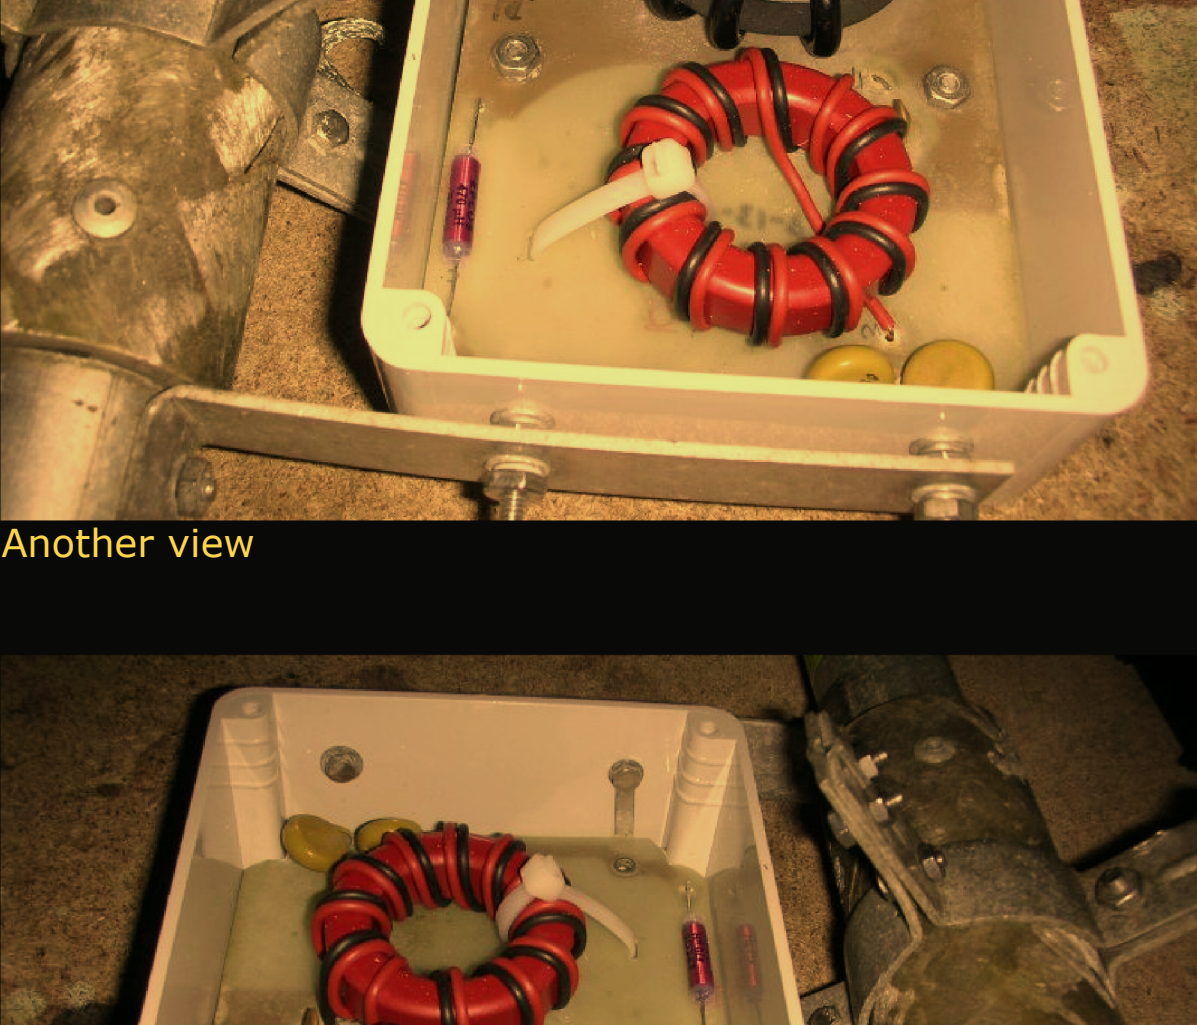
Another view

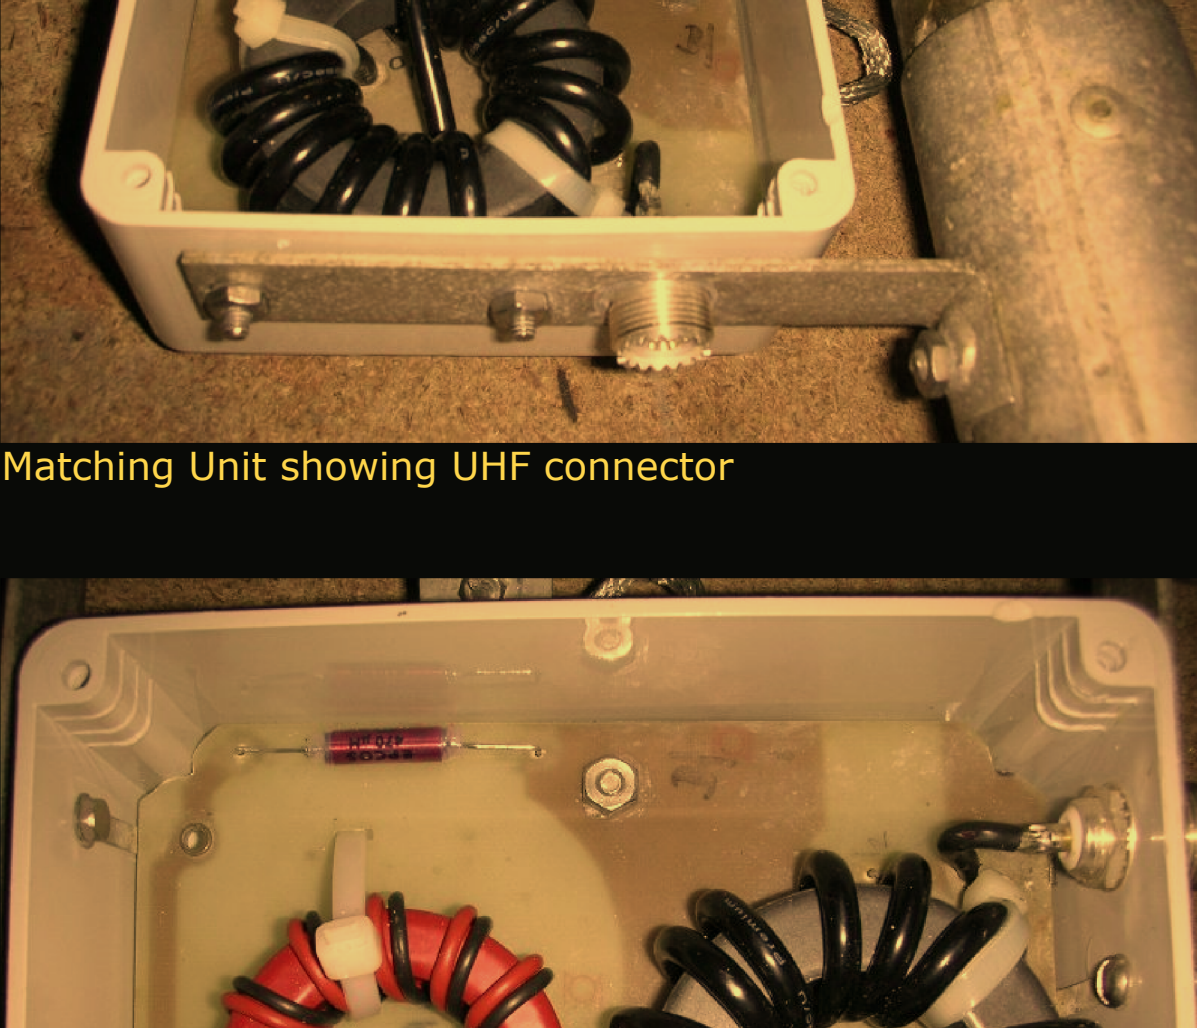
Matching Unit showing UHF connector

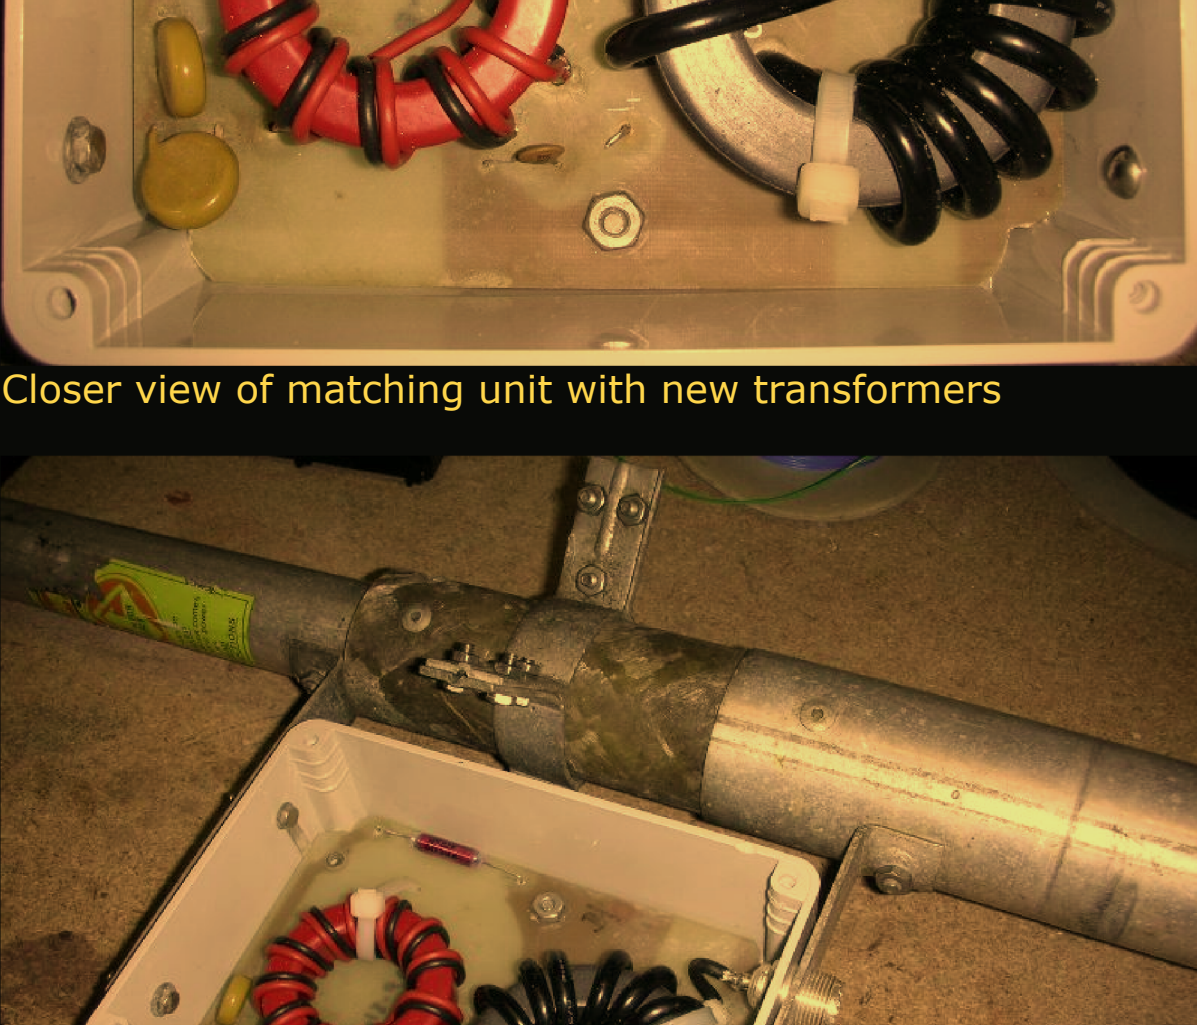
Closer view of matching unit with new transformers

If you look closely, I have put in a new RF choke as the original one broke (they seem to be very fragile). The new choke is from Radio Spares (UK), part number, 2113-1932, 470uH, 0.3A (costs just under one UK pound).

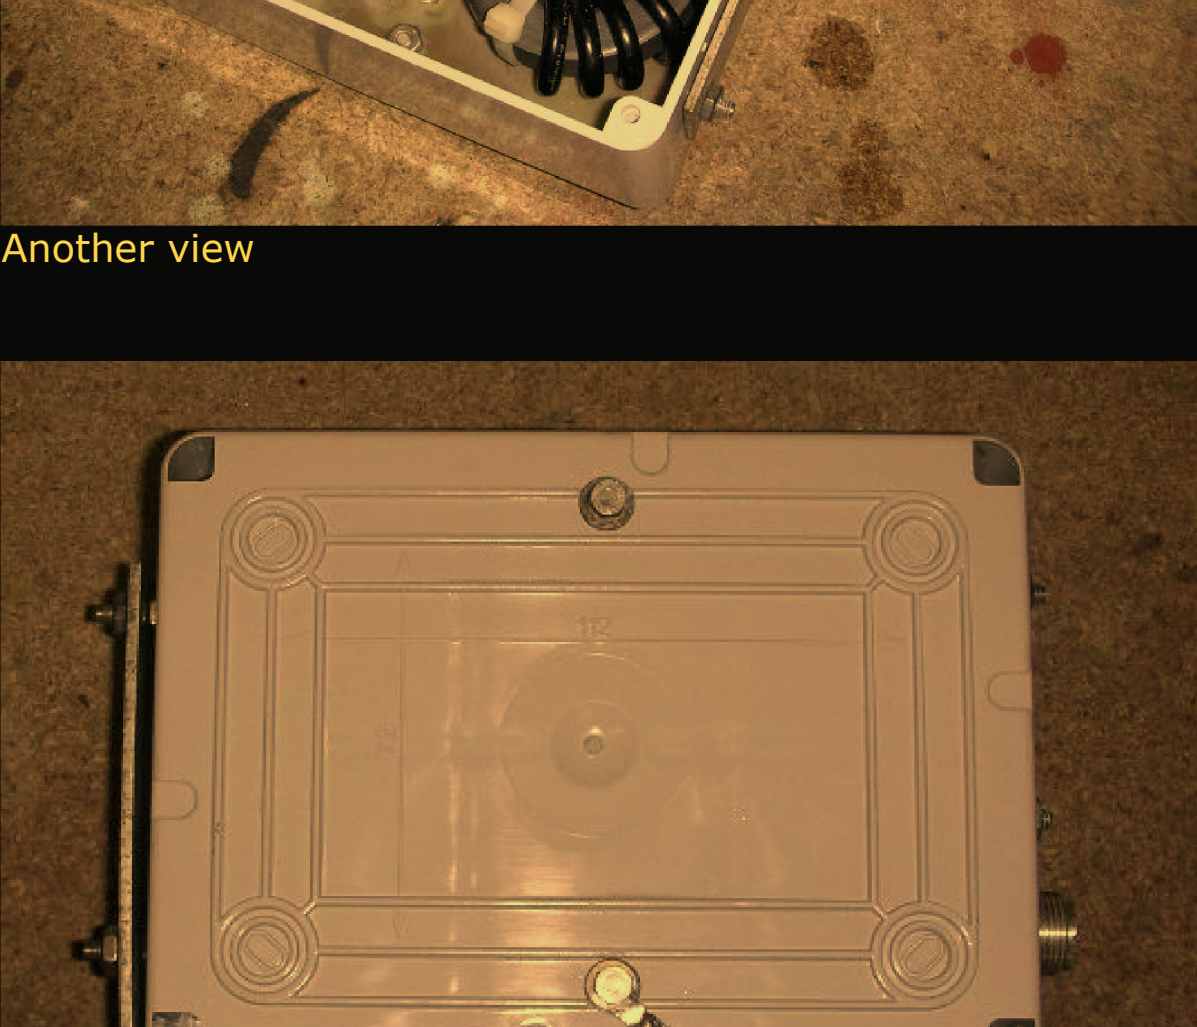
Another view

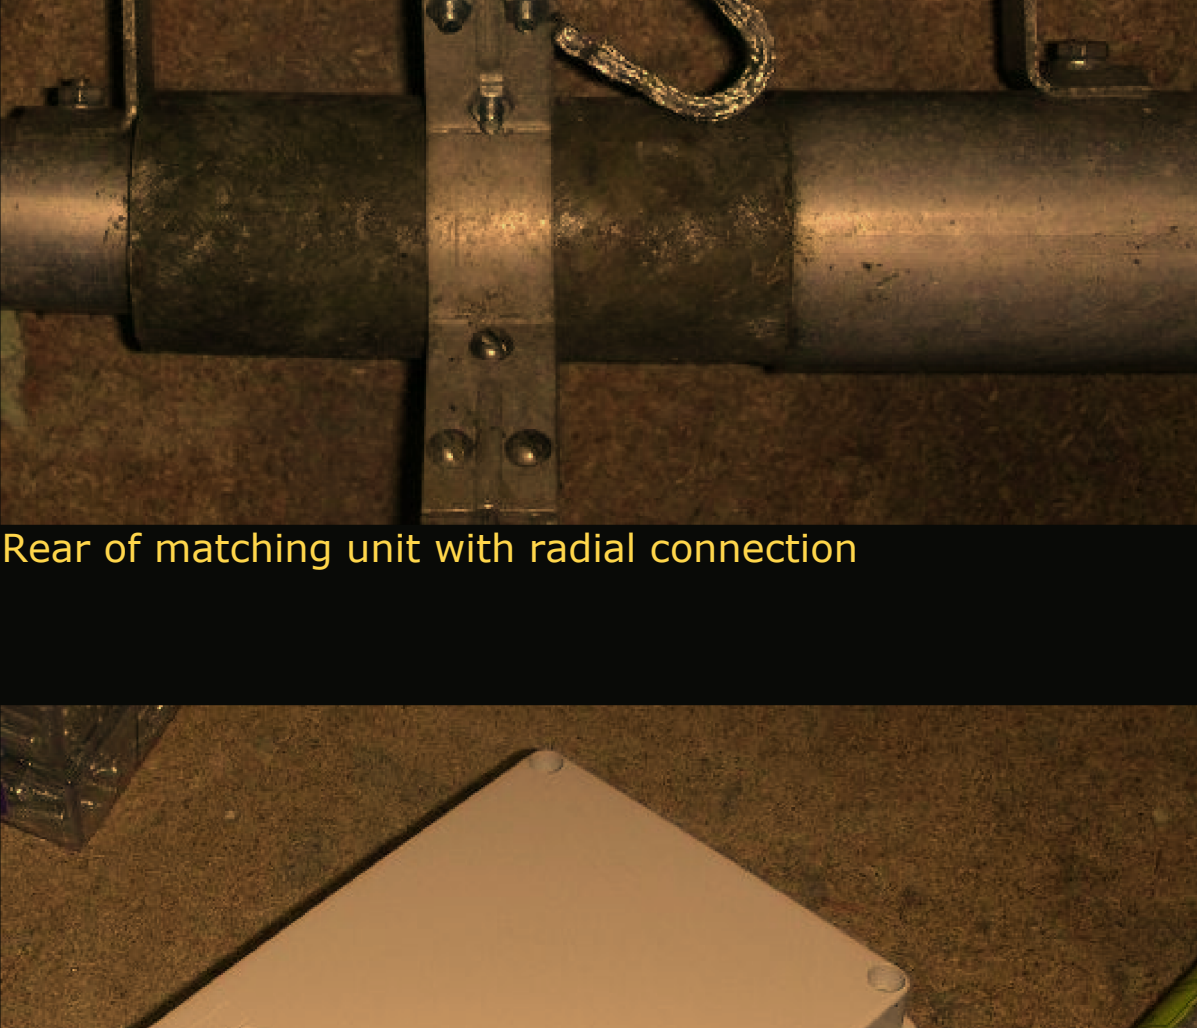
Rear of matching unit with radial connection

When rebuilding, make sure that the radial strap has a good contact with the underside of the PCB. I found that unless the bolt securing the PCB to the box was very secure, the contact caused an intermittent. This meant that the matching unit had 'no radials' and then simply didn't match at all.

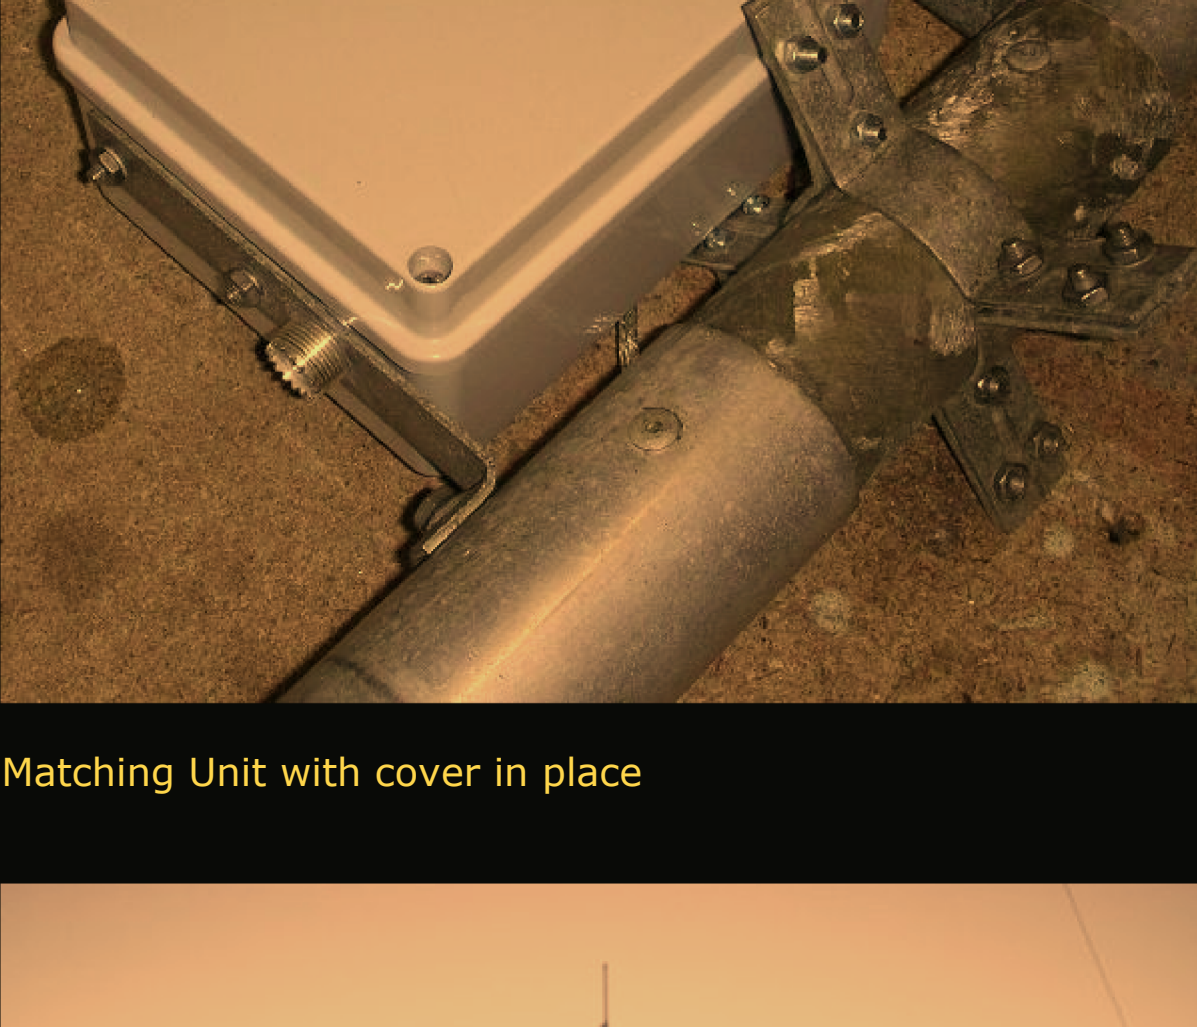
Matching Unit with cover in place

The box is from maplin, product number YM91Y and is one of their 'IP enclosure' range. The box is 150 x 110 x 70mm in size (product codes YM91Y - grey, YM93B - grey with clear lid). Cost is around six UK pounds.

It is physically the same size as the Cushcraft variant, but the PCB has to be slightly 'nibbled' at the corners to get it to fit inside the newer box. I'd say the original Cushcraft enclosure isn't that good as they used steel screws into brass fixings. The screws rust over and then shear off. In my view, the Maplin IP enclosure is a better solution to outdoor use (IP56 rated).

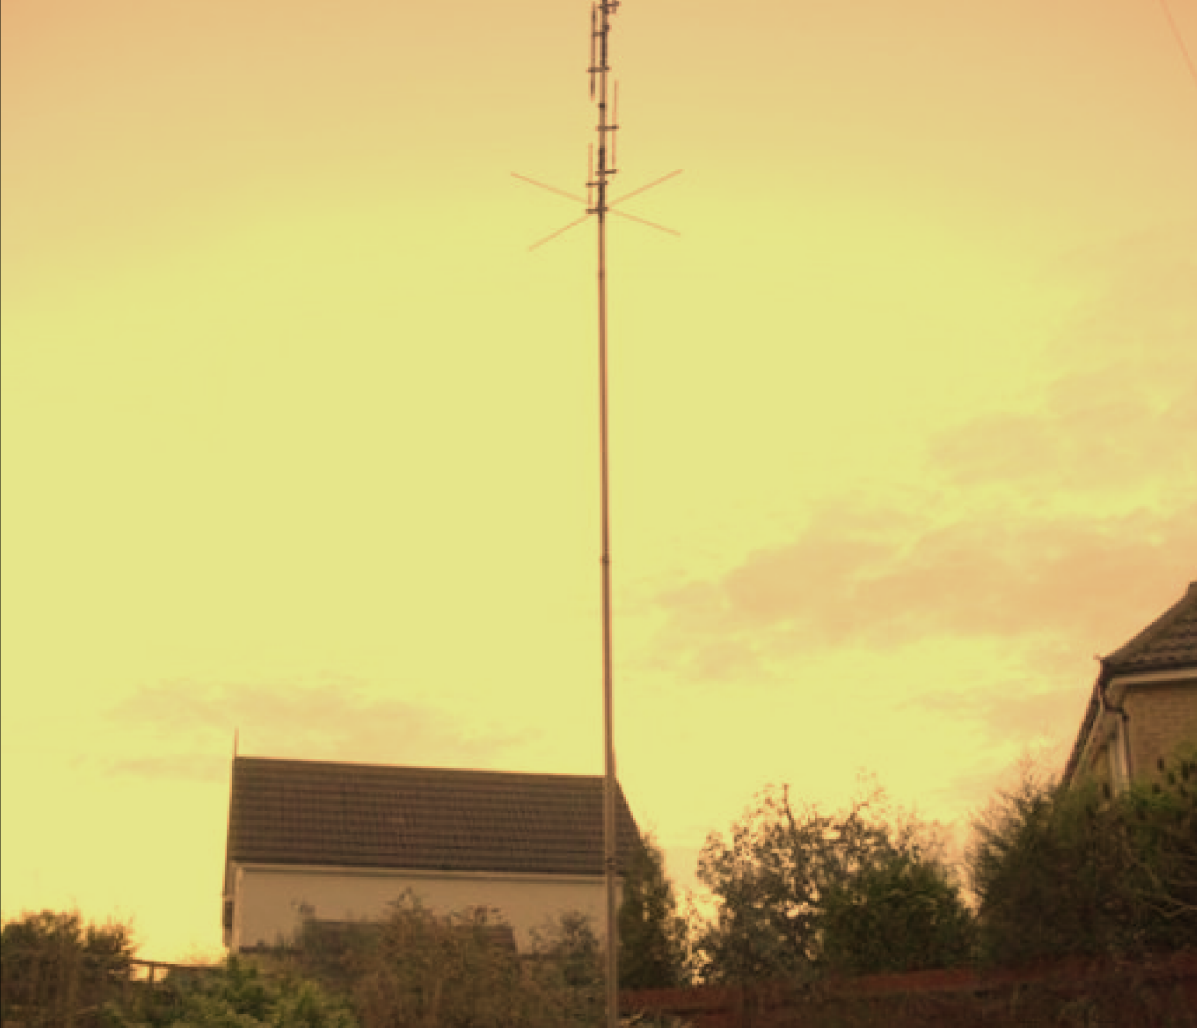
View of the complete R5 system as put together
